Operation TEAPOT

Project 31.2

DAMAGE TO COMMERCIAL AND INDUSTRIAL BUILDINGS
EXPOSED TO NUCLEAR EFFECTS

Bruce G. Johnston

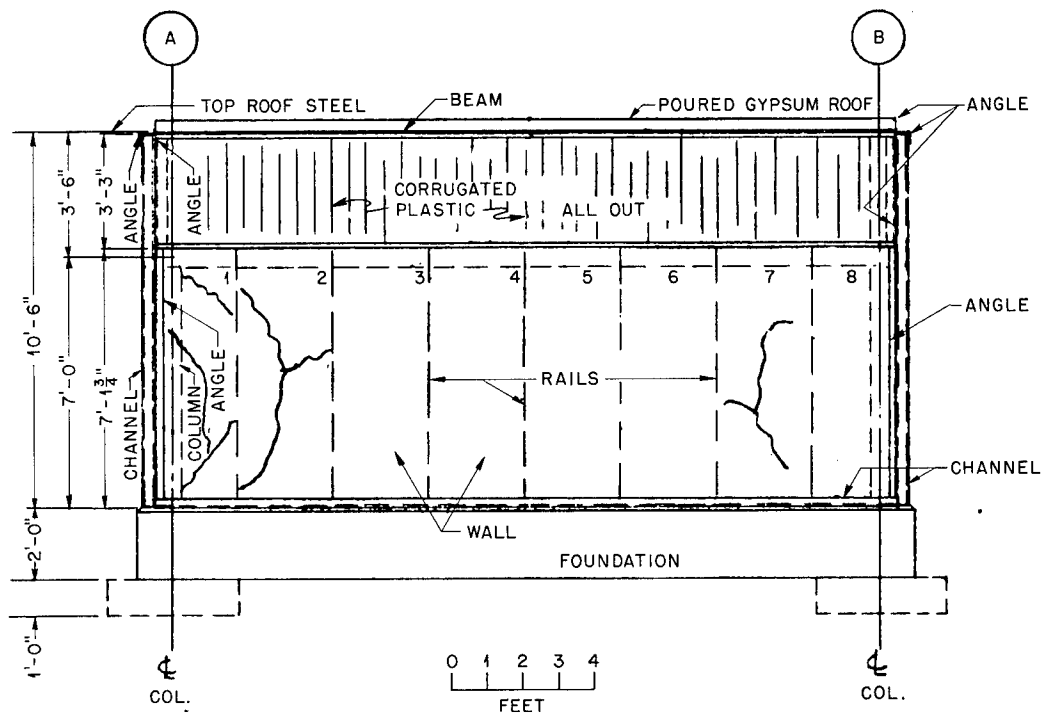
Fig. 1.3—Front elevation of Union Carbide building.

The reinforced-gypsum walls suffered only slight damage. The wall facing the blast (Fig. 1.3) showed moment cracks on the interior surface. These cracks were a maximum of $\frac{1}{32}$ in. in width, and they occurred in three of the panels formed by the vertical steel rail studs. The south wall, away from the blast center (Fig. 1.4), developed a horizontal crack approximately $\frac{1}{16}$ in. in width, starting near the southeast building column and extending across one-third of the bay. The east and west walls showed no moment cracks, but several shear cracks developed in the west wall at the top of the panels at roof level near the door opening, as shown in Figs. 1.6 and 2.16.

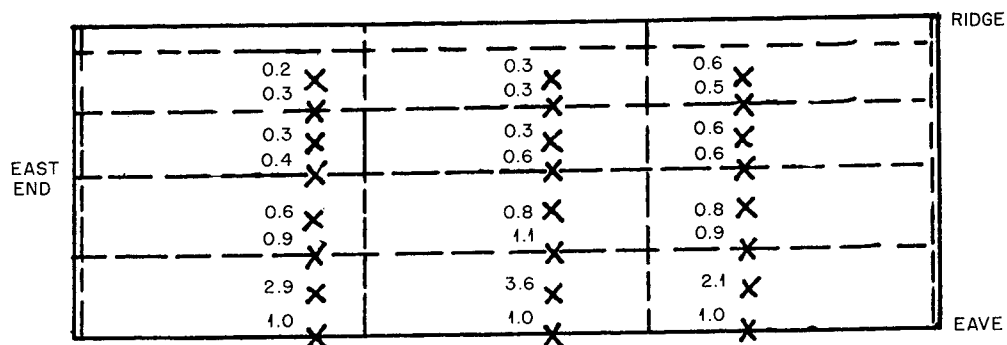
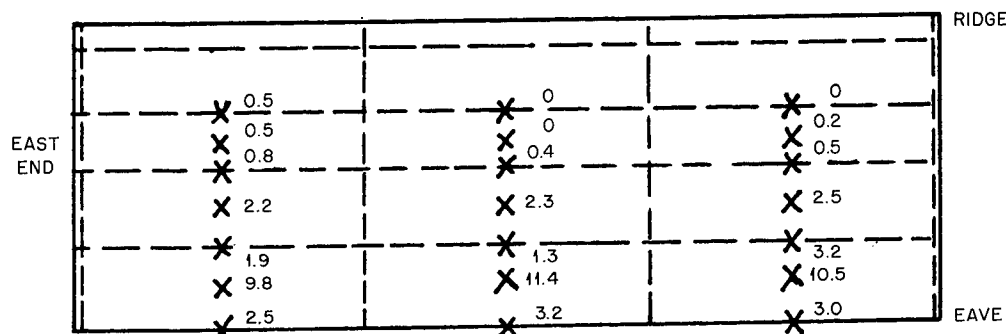
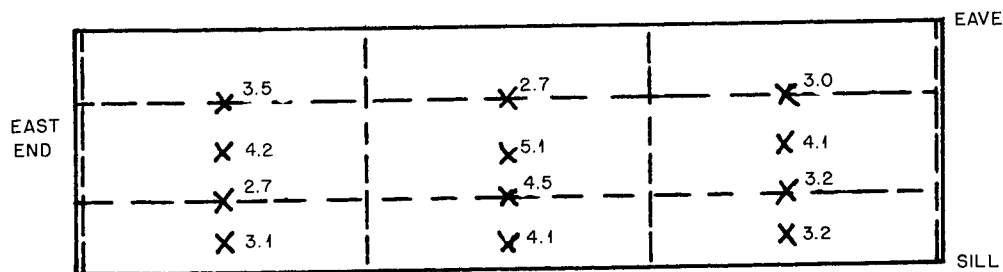
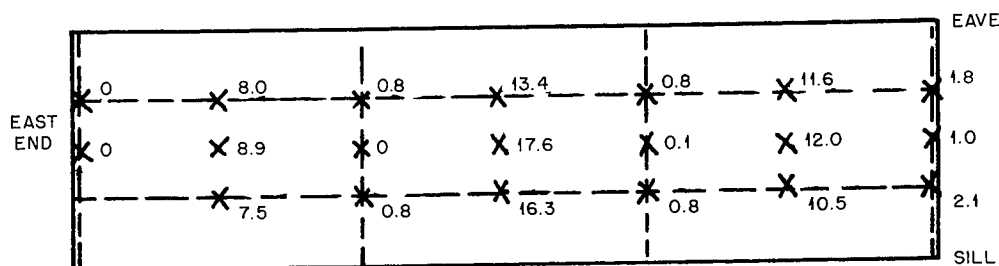
Fig. 2.2—Offset measurements of permanent wall and roof deflections in inches in Reynolds-Butler buildings in which sheeting remained in place.

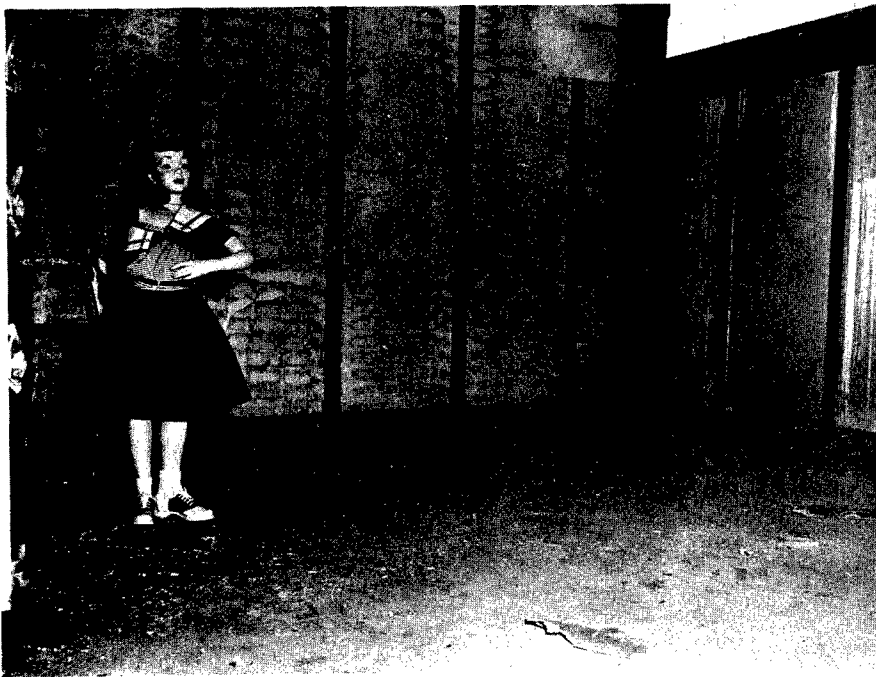
A mannequin standing erect in the center of the building was still erect and virtually unharmed after the blast, as shown in Fig. 2.13. The stylus points of three of the four scribes were destroyed, but general indications were obtained as to movements of structural members.

Fig. 2.13—Interior view of southeast corner of Union Carbide building after planned test.

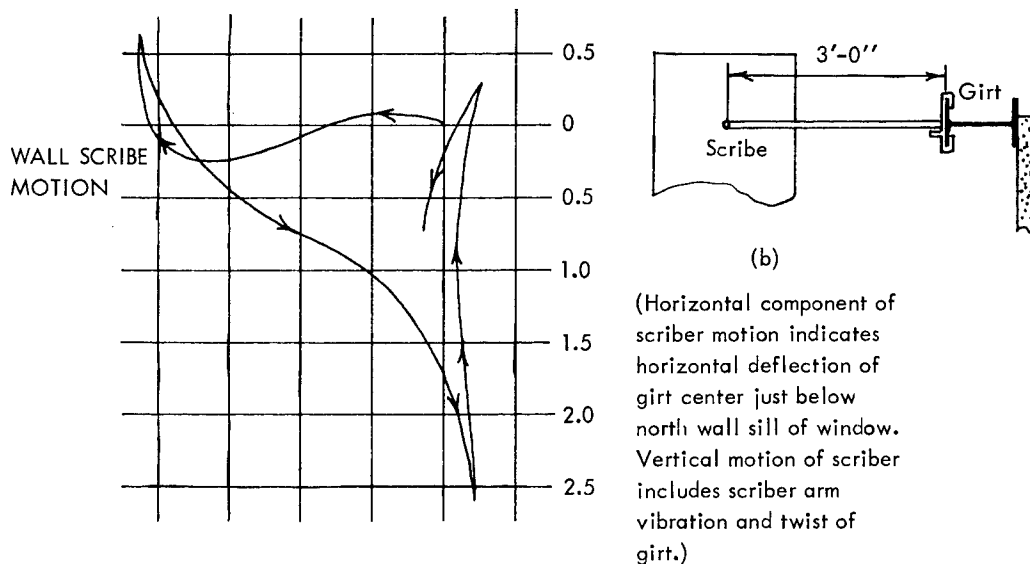
Severe vertical roof movements were indicated on scratchboards, and these movements are recorded in Fig. 2.14 at the one available location. No permanent deflections were recorded for any roof beams, except for the beam one panel from the south wall, which had a permanent upward deflection of $\frac{1}{8}$ in. at the center of the beam.

1. Horizontal girt in north wall: torsion and horizontal deflections, as shown in Fig. 2.14.
2. Roof girder at east wall: torsion in the girder, as shown by the impact mark on the scratchboard by the stylus pipe arm.
3. Roof beam, just north of center line: vertical displacement coupled with some torsional movement, as shown in Fig. 2.14.
4. Column in southeast corner (near girder): displacement approximately $\frac{1}{4}$ in. in north and south directions.

Fig. 2.14—Deflections of roof and north wall in Union Carbide building during planned test.

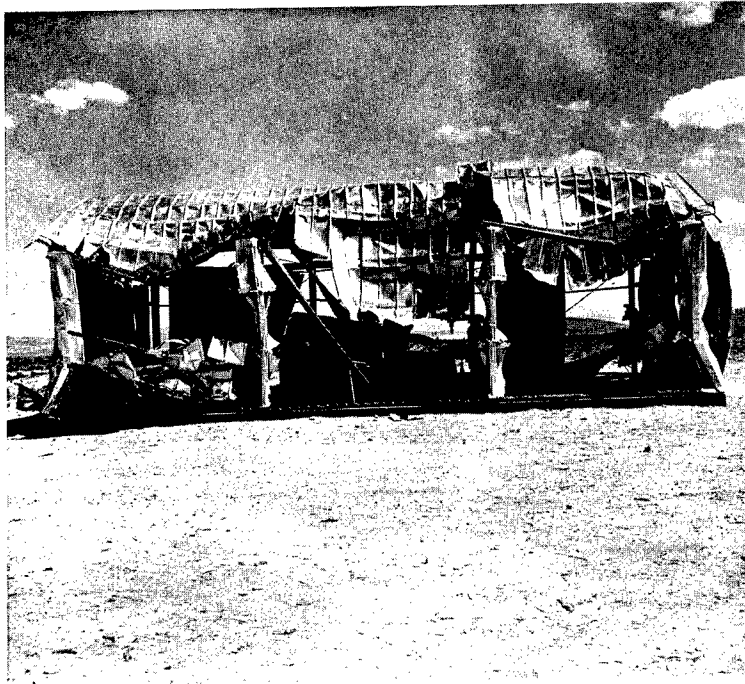
In addition, the two end frames at the north corners were bowed laterally inward, a distance of about 11 in. at each end, toward the center of the building. This inward deflection is quite noticeable in the general view of the north side, as shown in Fig. 2.17. The unbalanced tension in the girts at the ends, as well as the inward pressure, was undoubtedly a factor contributing to this inward movement. In addition, the girts showed evidence of having hung on the corner columns longer than on the interior columns, thus exerting a twisting and pulling action accentuated by drag on the crumpled mass of sheeting that remained attached to these girts.

Fig. 2.17—North side of Reynolds-Butler Building 31.2-a1 after planned test.

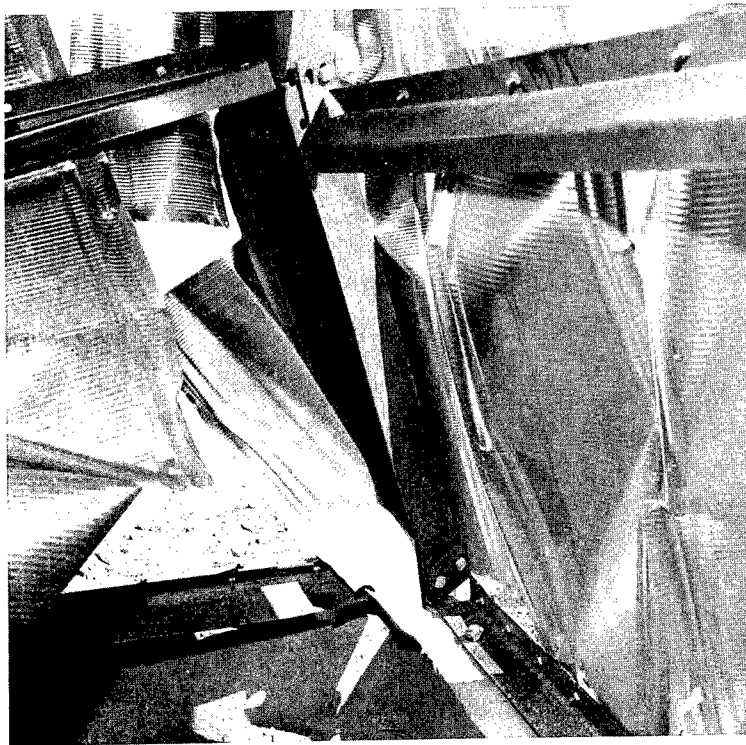
The columns, as a result of biaxial bending inward, experienced fractures at the bolt holes at the level of the lower girts. The local bent, twisted, buckled, and fractured condition at these details is shown in Figs. 2.18 and 2.19 for the northeast and northwest columns, respectively.

Fig. 2.18—Interior detail of northeast column in Reynolds-Butler Building 31.2-a1 after planned test.

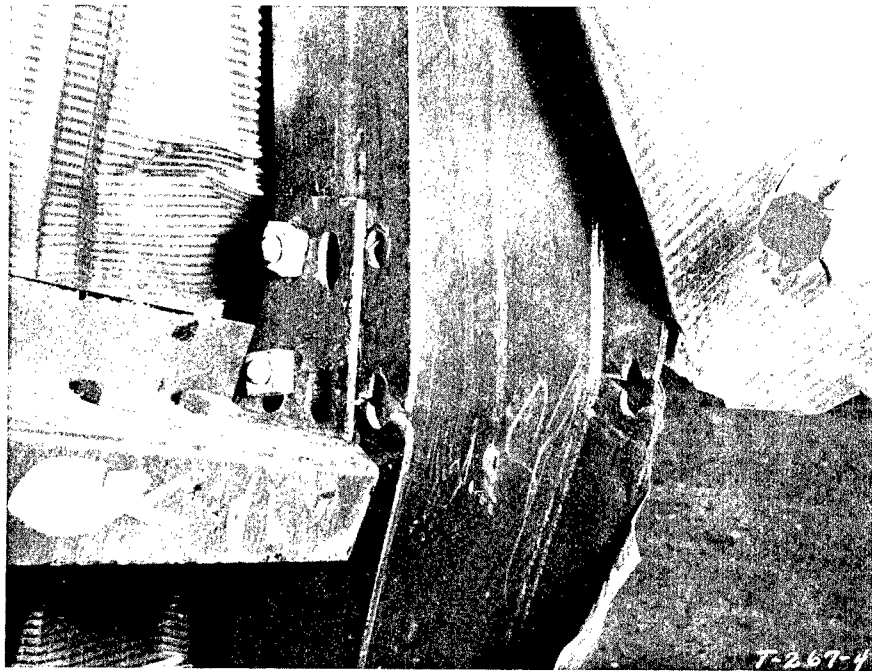
Fig. 2.19—Interior detail of northwest column in Reynolds-Butler Building 31.2-a1 after planned test.

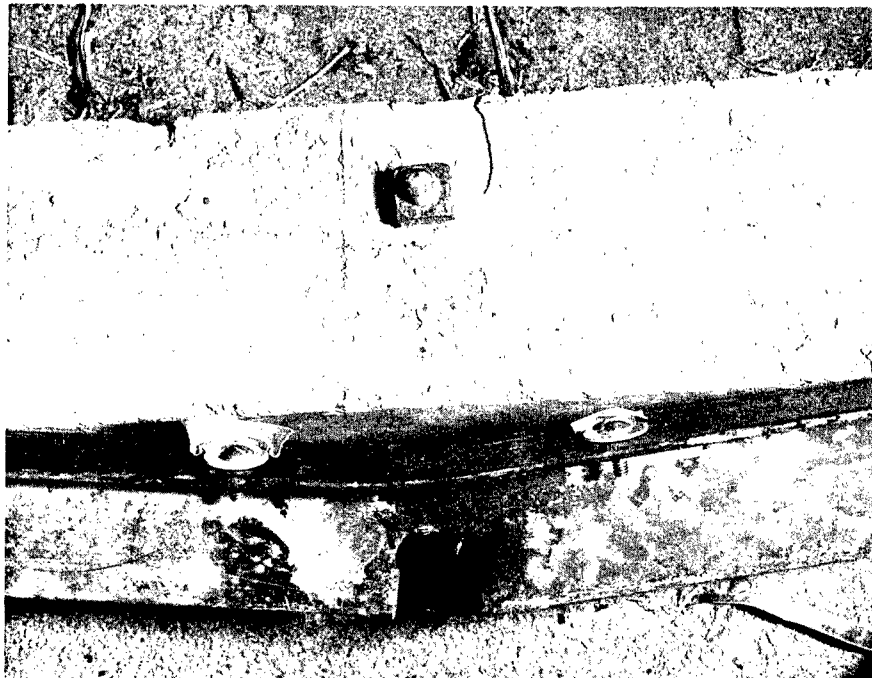
Fig. 2.20—View looking down on sill angle in Reynolds-Butler Building 31.2-a1 after planned test.

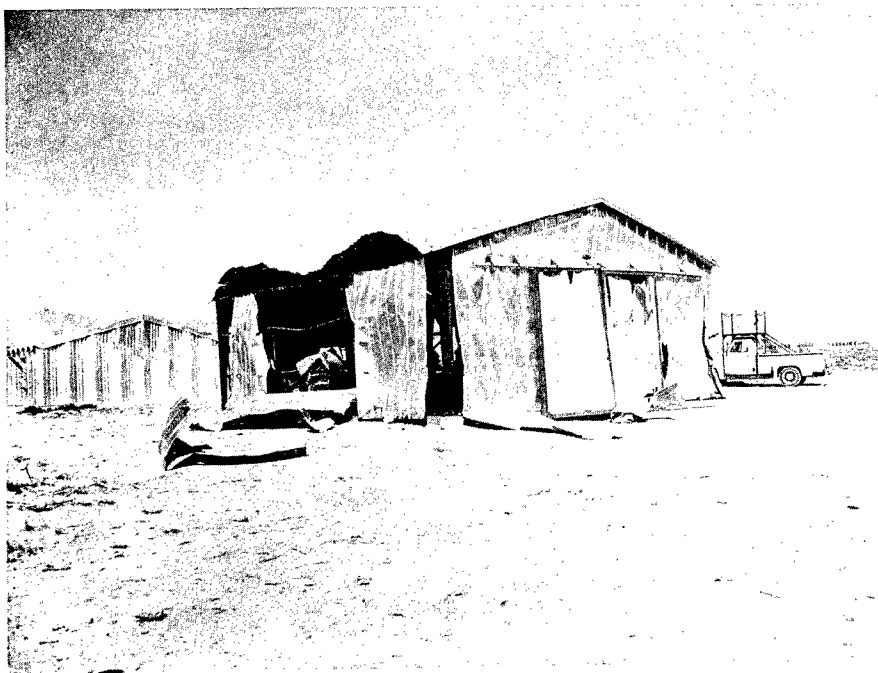
Fig. 2.26—South side and east end of Reynolds-Butler Building 31.2-a1 after planned test.

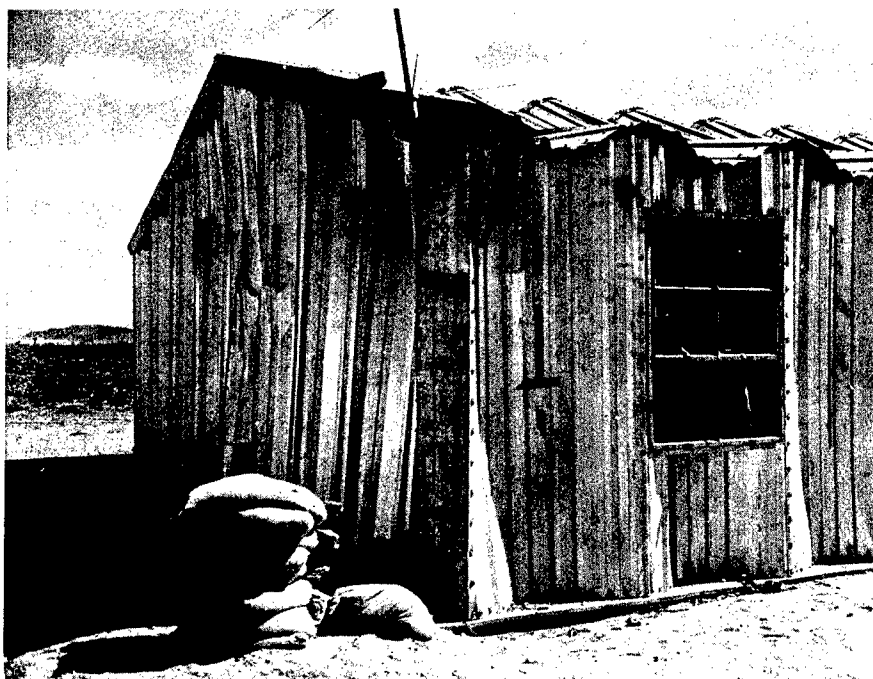
The ends of the building suffered minor damage, as shown in Figs. 2.34 and 2.35. The north half of the east end of the building was tilted toward the west, or center of the building, by varying amounts. In addition, the central panel was bent inward approximately 7 in. at mid-height. Along the sloping northeast corner of the roof, the inward tilting of the end wall segments (Fig. 2.35) varied from 11 in. at the panel next to the eave corner to 2 in. at the ridge. At the west end of the ridge, the end wall remained essentially plumb, but it was bent inward locally about 2 in. near the center. Also, adjacent to the west end, there was severe local buckling near the top, which can be noted from the interior close-up view shown in Fig. 2.36. At this point, also, can be noted the failure between the longitudinal end strut and its connection to the end wall of the building, with permanent displacement in the direction of the ridge line of about 4 in.

Fig. 2.35—Northeast corner of Behlen Building 31.2-b1 after planned test.

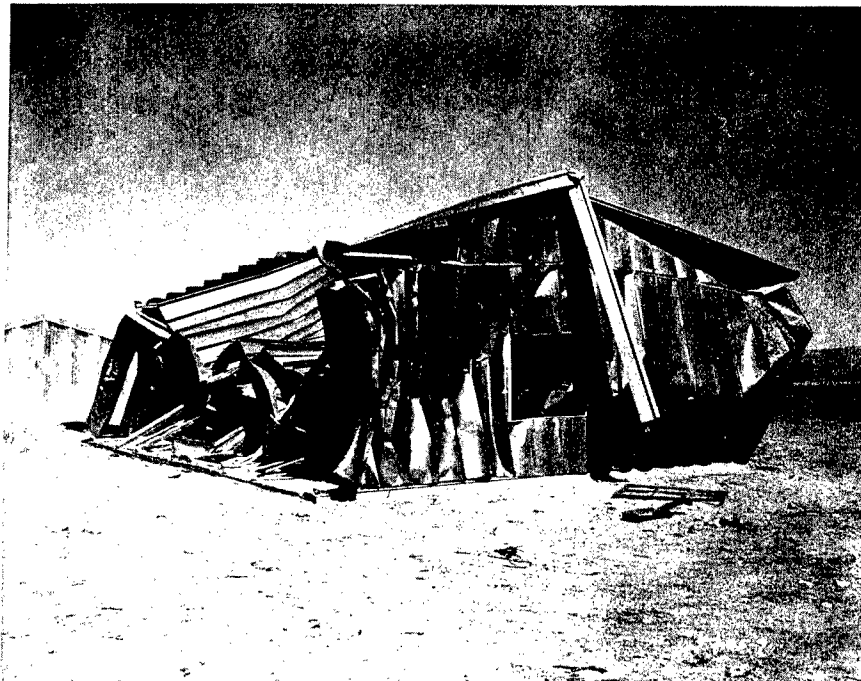
The north side of the building is shown in Fig. 2.37, which also indicates the sag in the roof. Figures 2.38 to 2.41 show various views of the crumpled ends and the south side of the building. Most of the wall segments remained on site, although the wall panels along the north side were largely torn loose from the wall sill connections, as shown in detail in Fig. 2.42, and one piece swept downblast about 50 ft. At the southwest corner of the building, the sill was also torn loose, as shown in Fig. 2.43. The wall paneling remained attached to the sill along 75 per cent of the east end and all the west end.

Fig. 2.38 — West end of Armco Building 31.2-d1 after planned test.

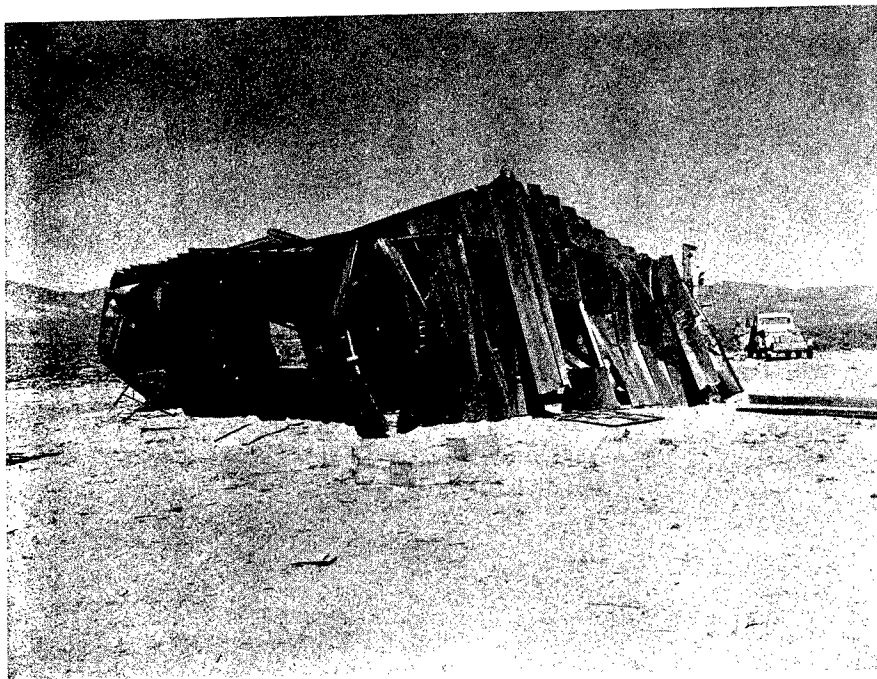
Fig. 2.41 — East end and south side of Armco Building 31.2-d1 after planned test.

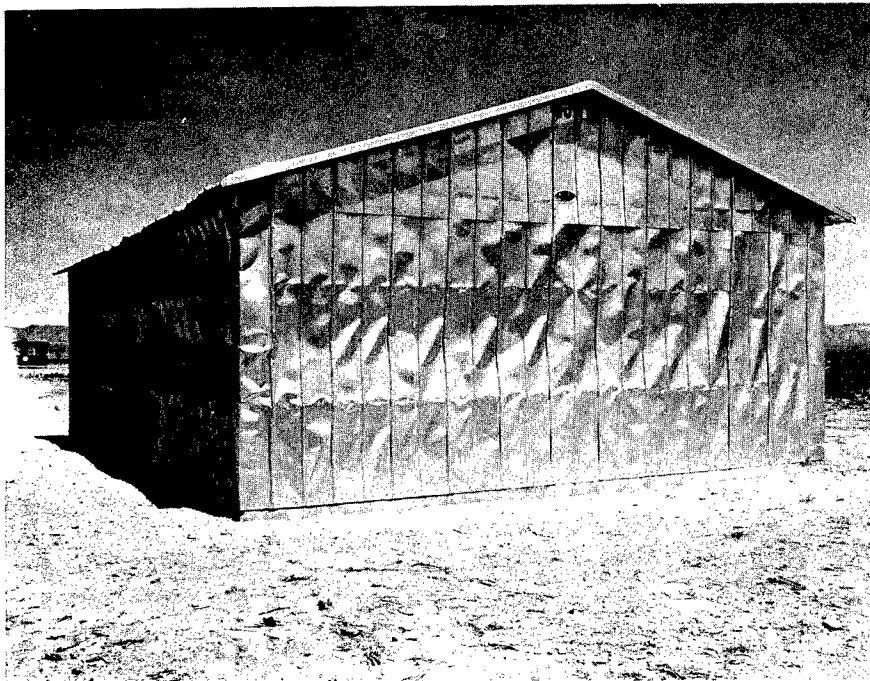
Fig. 2.48—West end of Reynolds-Butler Building 31.2-a2 after planned test.

A general description of these buildings is given in Sec. 1.3.2, and general drawings, are shown in Figs. 1.10 and 1.11. Over-all behavior during the unexpected test is described in Secs. 2.1.2 and 2.1.3, and behavior during the planned test is described in Secs. 2.2.3 and 2.2.6. Figure 2.1 shows the wall after the unexpected test, and Fig. 2.2 records the measured offsets of permanent wall deflection after both the unexpected and planned tests. Figures 2.3 to 2.5 show other views of damage to the walls and roof which resulted from the unexpected tests, and Figs. 2.46, 2.48, and 2.49 show the wall condition after the planned test at the 15,000-ft line.

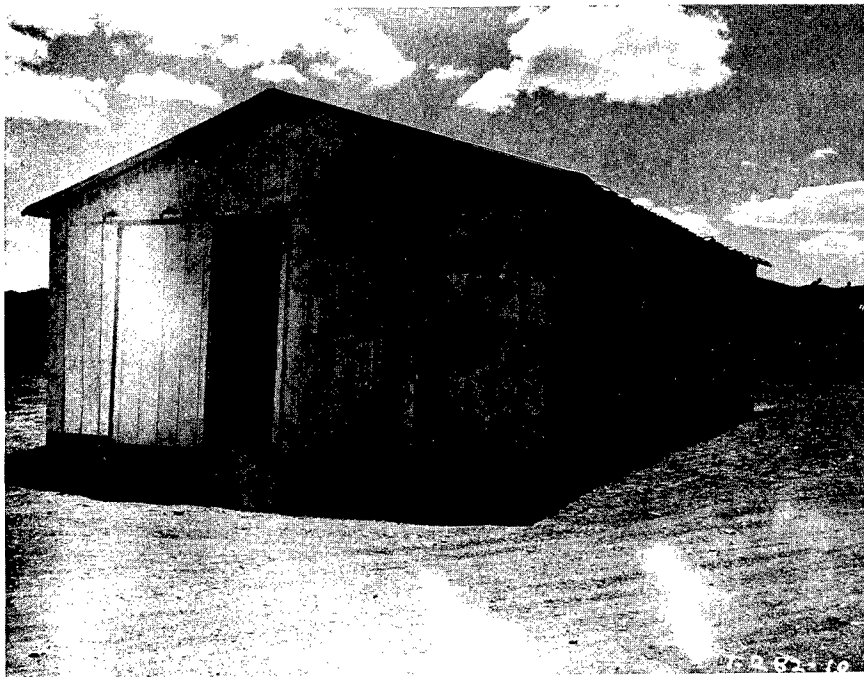
Fig. 2.49—East end of Reynolds-Butler Building 31.2-a2 after planned test.

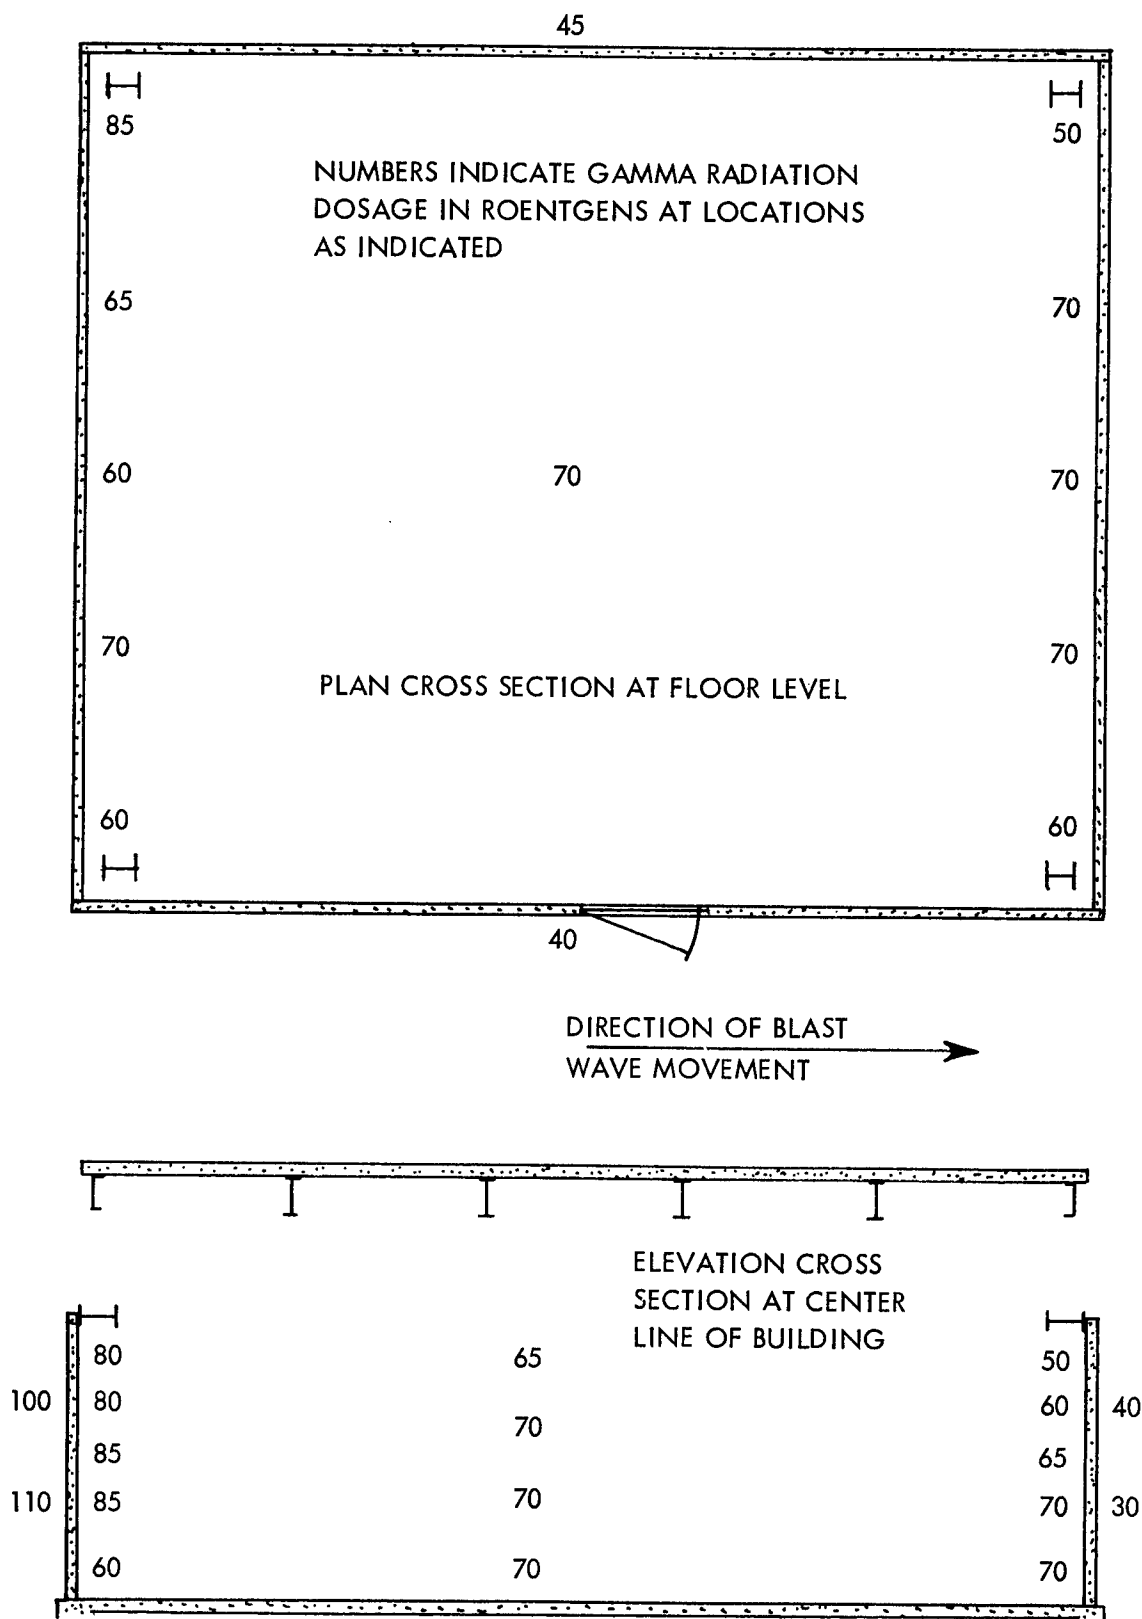
Fig. 2.54—Gamma radiation measurements in Union Carbide building.

In the case of the Union Carbide building at 5500 ft, with 4-in. reinforced-gypsum walls, there were significant variations in film-badge readings. A vertical cross section running north and south at the center line of this building and a horizontal cross section at floor level are shown in Fig. 2.54. The only reading not recorded in Fig. 2.54 is one on the outside center line of the east wall at about mid-height of the building which gave a reading of 80 r. The gauge near ground level at the same location had a reading of 45 r, as shown. The reduction in radiation levels behind the structure, as compared with those in front of the structure, is quite significant.
